CAR-19
Marblehead
Ridgely
Private

National Register of Historic Places Registration Form

Marble Head, CAR-19	
Name of Property	_
Caroline County, Maryland	
County and State	_

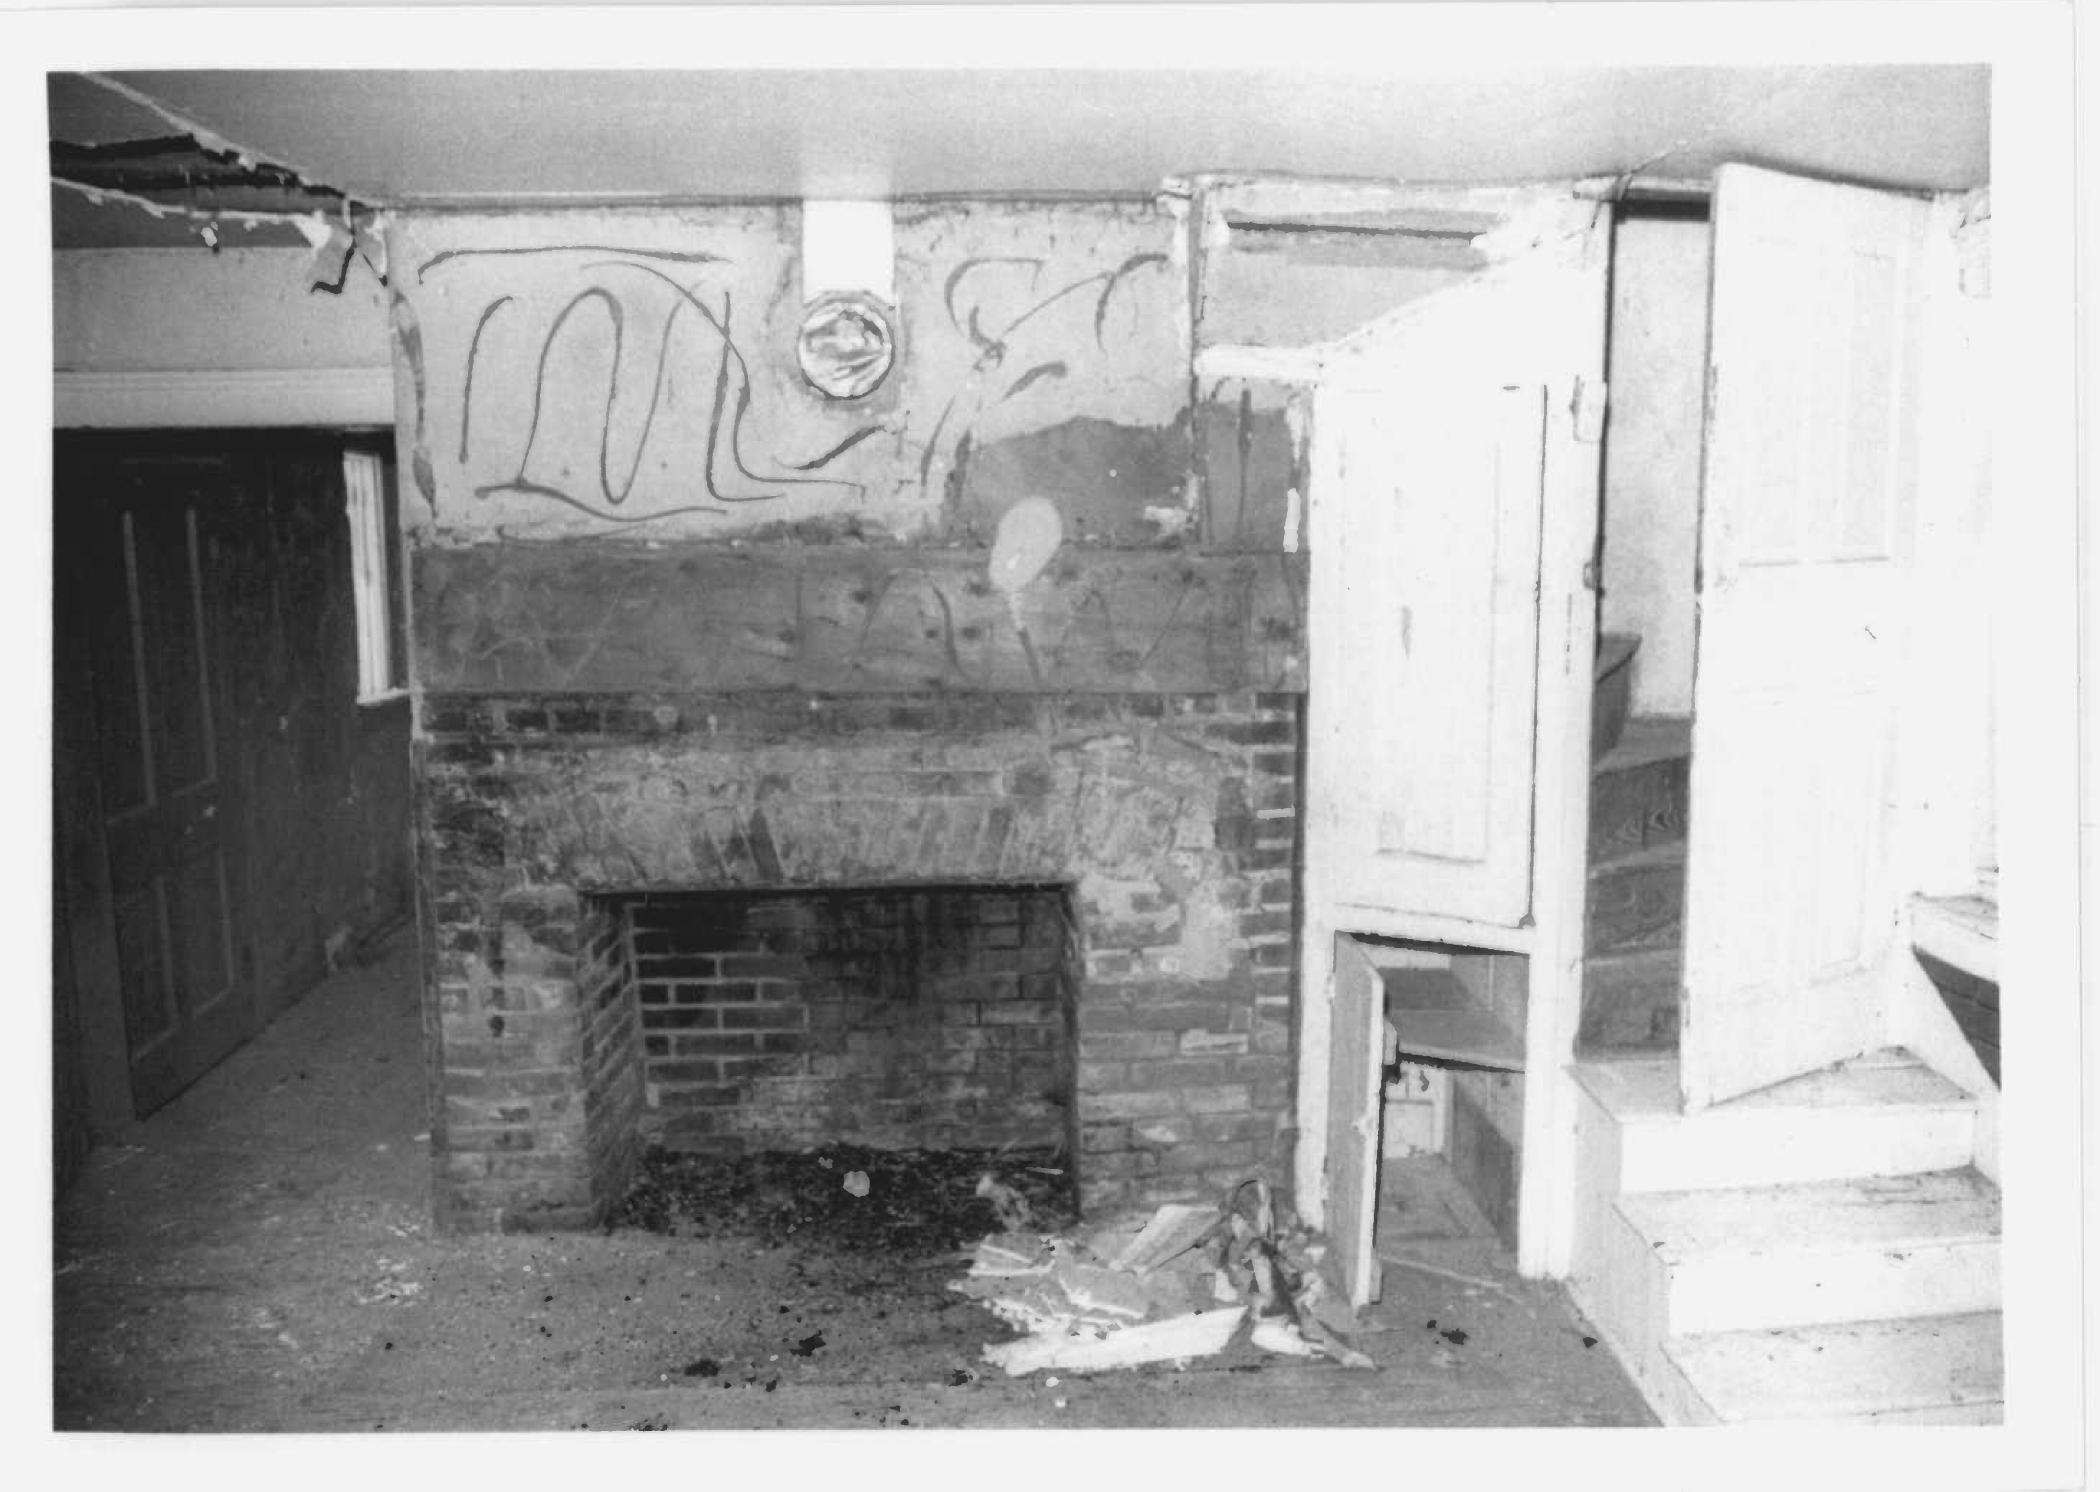
CAR-19 MARIBLE 1+EMD PIDLERY VIC. CAROLINE C. MA SERVICE WING - FIRST FROM FIREPLACE AND NINNER STAR 5/01, PAUL TONANT, PITOTOLAMITERE 20 04 22

The two-story service wing has a two-room plan with a kitchen in the south end and an informal dining room adjacent. Several bold ovolo or cavetto backband surrounds frame the principal door openings and suggest that the rear service wing was erected before the main block and hyphen. The kitchen retains the original cooking fireplace fitted with an iron crane. An adjacent winder staircase, located in the southwest corner was rebuilt during the late nineteenth century. In the southeast corner is a built-in late nineteenth-century cupboard. The room has exposed joists covered in layers of whitewash. Located above the kitchen is a plastered slave chamber served by a rudimentary fireplace. The walls have a bright blue color over a red ochre color. This room originally had an exposed joist ceiling that was plastered over during the late nineteenth century. Remnants of whitewash are evident on exposed sections of joists.

Adjacent to the kitchen is an informal dining room fitted with a smaller fireplace that has lost its decorative surround. Fitted in the southwest corner is a winder staircase entered through a raised-four panel door. Smaller flat panel doors directly adjacent open into small closets. The
